# EXHIBIT “A-1”

February 26, 2016

Insured:	Joseph & Ursy Vitale
Loss Location:	1812 Purdie Lane Maple Glen, PA 19002
Co. Claim #:	0339957135
Date of Loss:	9/4/14
Type of Loss:	Fire
WGI File #:	60294

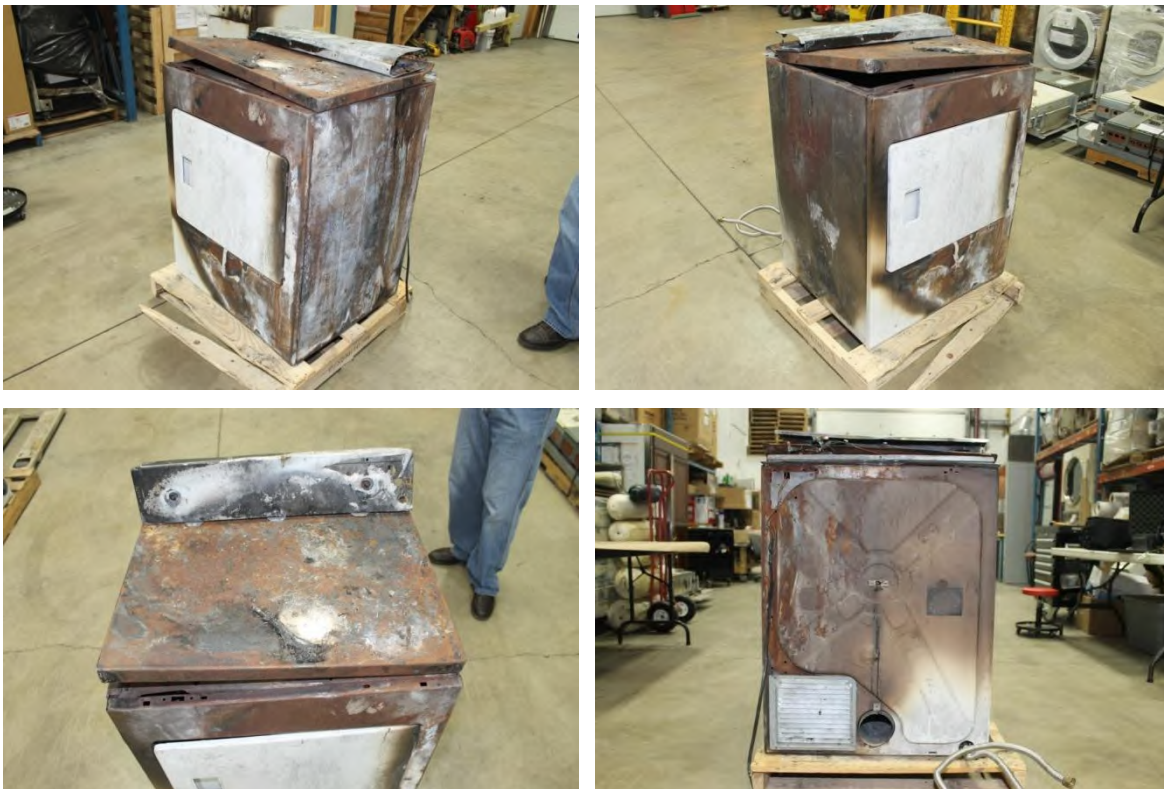
**Exterior of Subject Dryer**

The exterior examination of the dryer revealed heat damage and oxidation patterns to the right front corner of the appliance consistent with the plastic trap duct/blower housing being consumed during the fire. The left side of the cabinet also displayed heat damage but the paint was still partly intact at the bottom-left. The top lid was oxidized most heavily at the right front corner. The rear of the cabinet has heat damage to the paint. All exterior fire patterns are consistent with the fire originating within the dryer.

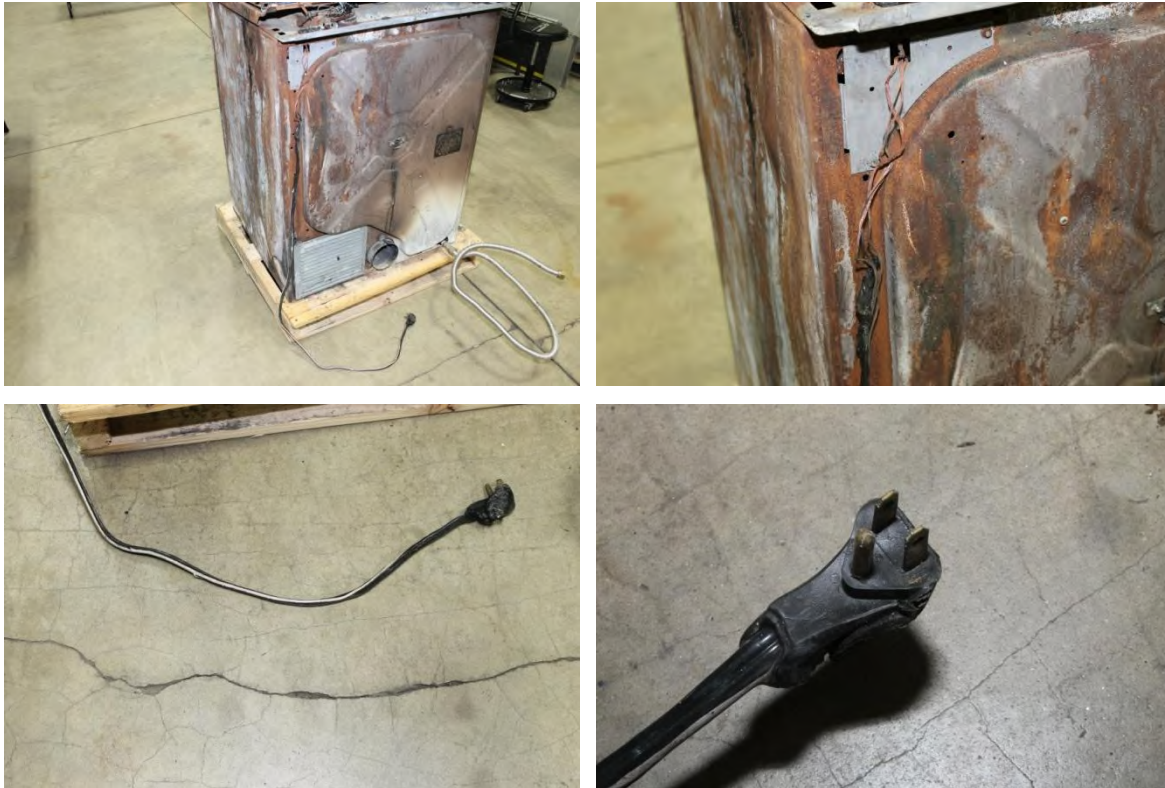
**Power Cord**

Examination of the rear of the dryer revealed the power cord terminal cover was intact and in place. The 120V power cord was still attached to the cabinet. The insulation on the cord was partly consumed in some areas, including the strain relief at the cabinet. The plug end had only minor melting to the exterior. There was no electrical activity observed on the power cord conductors.

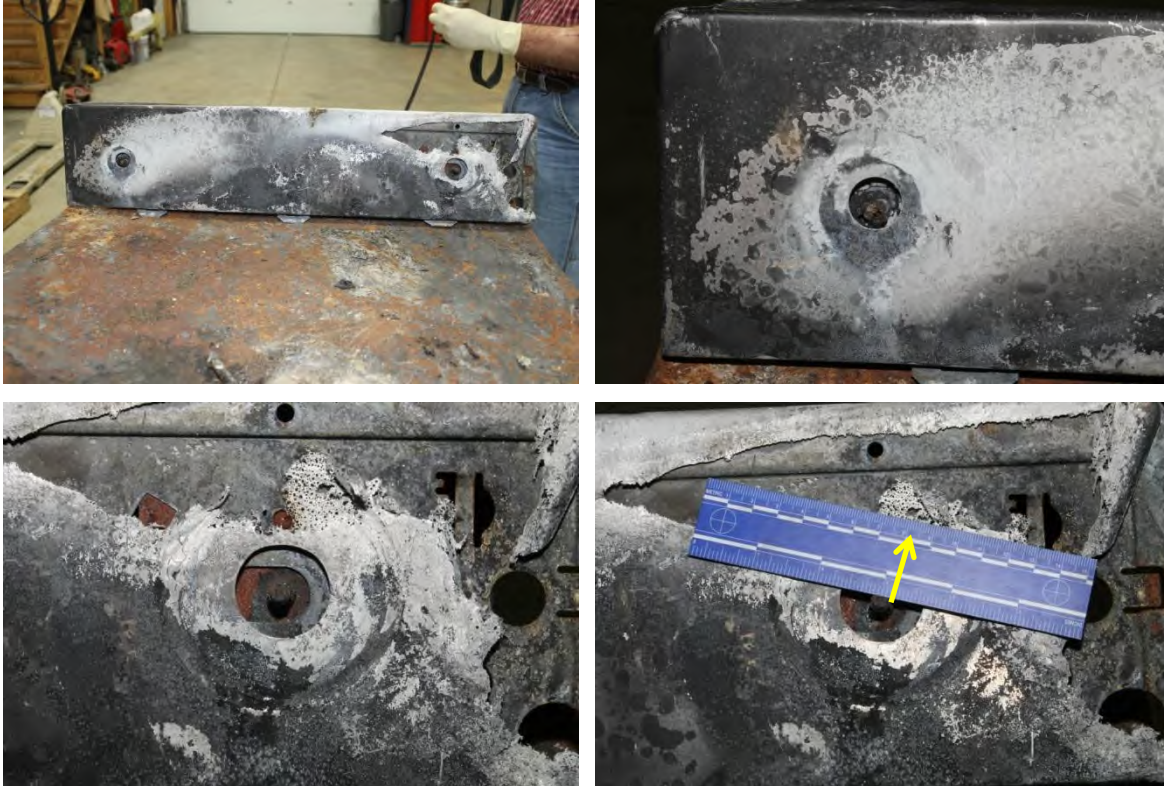
**Control Console & Timer Shaft Position**

The top mounted control console was heat damaged and both of the plastic end caps were consumed. The Timer and Start switch knobs were both consumed. The console was marked with the “GE” label and had the curved front unique to all Electrolux-manufactured freestanding GE dryers. The part number on the console was consumed, which did not assist in identifying the dryer model. The Timer shaft was loose and the shaft position was indexed toward the 1 o’clock position. The interior of the top mounted control console revealed that the switch bodies were damaged during the fire and the Timer could not be tested to verify if the dryer was running at the time of the fire. The insulation on the conductors in this area was completely consumed. There was no electrical activity observed on the conductors within the control console.

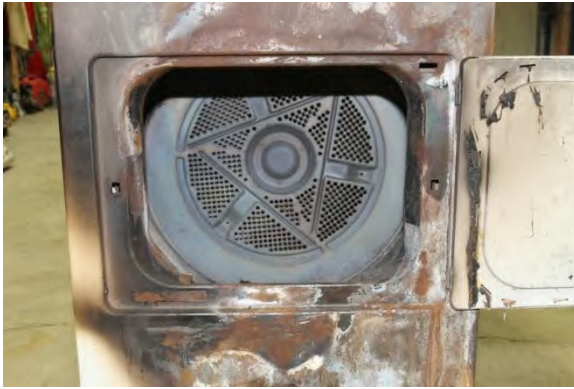
**Drum Opening**

The paint on the interior of the door was mostly intact whereas the paint on the drum opening had been consumed and the front panel heavily oxidized. This indicated the door was open during the fire. The door gasket had been only partly consumed. The door switch had been consumed during the fire. The door catches at either side of the drum opening were consumed. The plastic lint trap at the lower portion of the drum opening had been consumed. The manufacturer's labeling around the drum opening was consumed and both the model and serial number were not legible. Although it was not present during the joint evidence exam, the

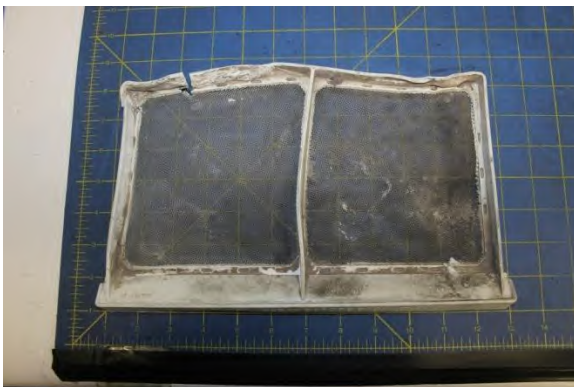
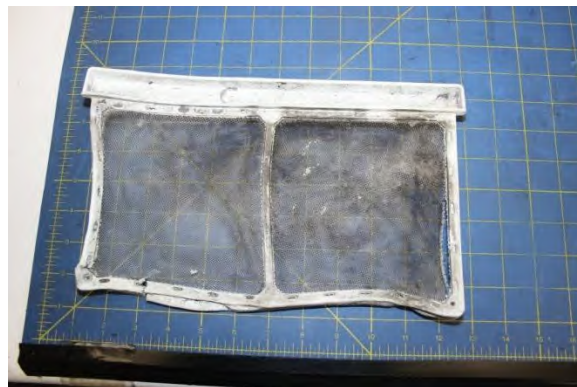
**Lint Screen Removed from Dryer during Fire Discovery**

insured had retained the lint screen from the lint trap at the front of the drum opening after the fire. Inspection of the lint screen revealed that the nylon screen material had some soot discoloration and the plastic frame was deformed from heat. Both sides displayed this type of damage and are consistent with the lint screen being in the dryer at the time of the fire and removed during fire discovery. Had the lint screen been left out during the last drying cycle, the downward facing side would have been protected against whatever the lint screen was laid upon.

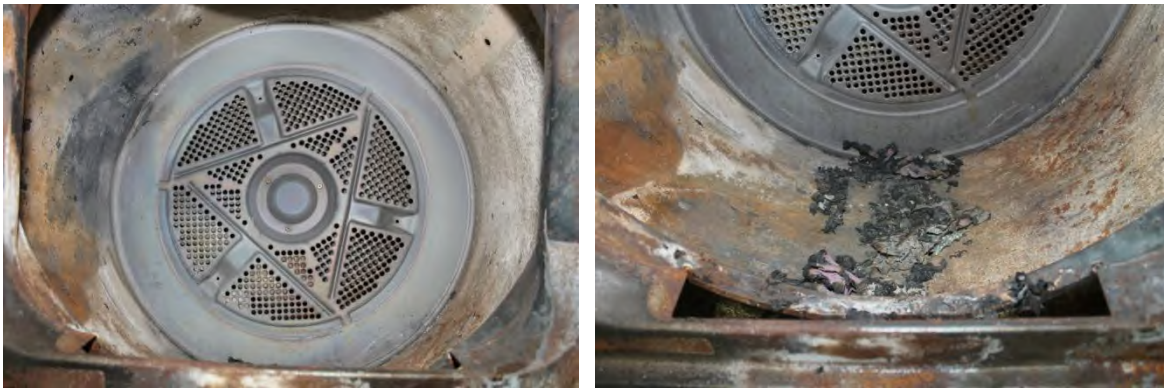
**Interior of the Drum**

The interior of the drum had heavy heat damage. All three of the plastic drum paddles were consumed. A load line was observed in the drum at the 10 o'clock position that indicated the drum had been rotated post-fire. The remains of the load had been mostly removed and preserved in a metal can at the fire scene. However, the burned cloth remains in the drum at the time of inspection included purple cotton blend cloths reminiscent of t-shirt materials and white terrycloth consistent with towel. The fire patterns on the cabinet surrounding the drum were not consistent with a fire that originated in the drum load. Additionally, the witness testimony does not support that the fire was caused by spontaneous ignition, as the dryer was running at the time of the fire.

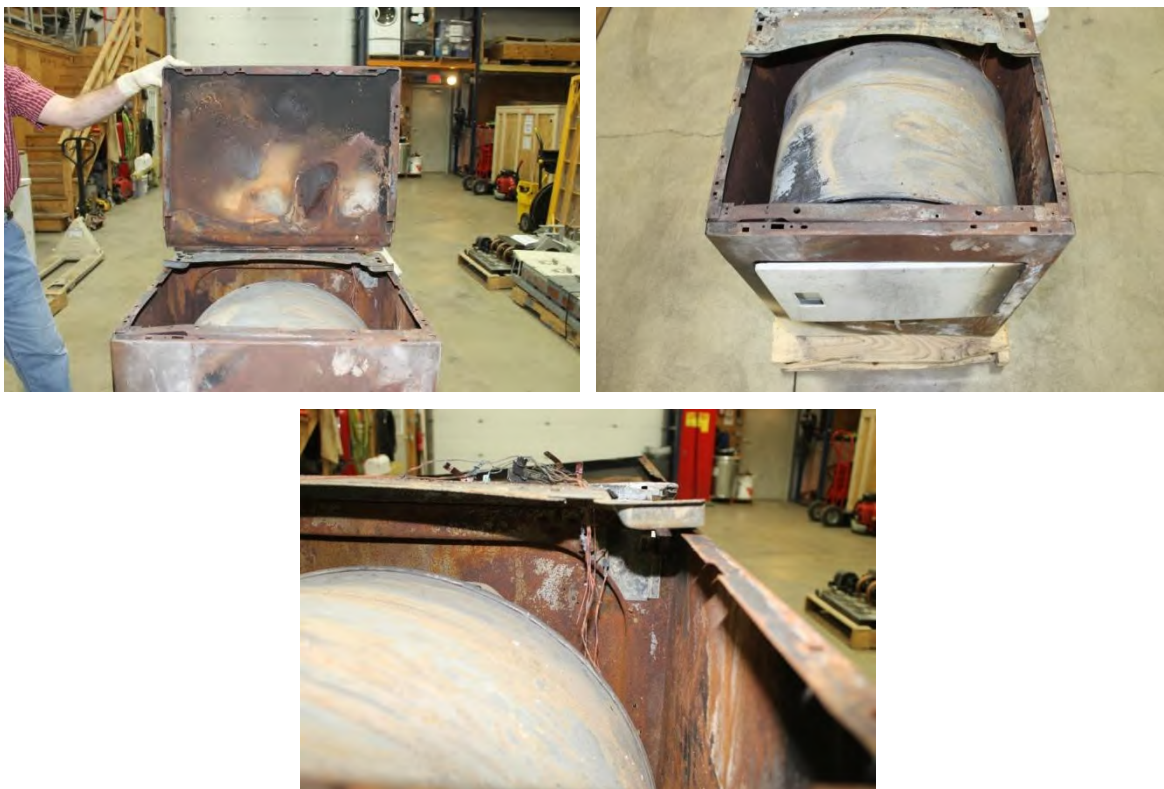
**Upper Cabinet and Upper Wiring Harness**

The top panel was removed and the belt was consumed. Both of the OEM screws fastening the front panel to the cabinet were in place. The insulation had been consumed from the upper electrical harness and a portion of the harness had broken away and dropped into the base of the

dryer cabinet. No electrical activity was observed on the stranded copper conductors remaining in the upper cabinet.

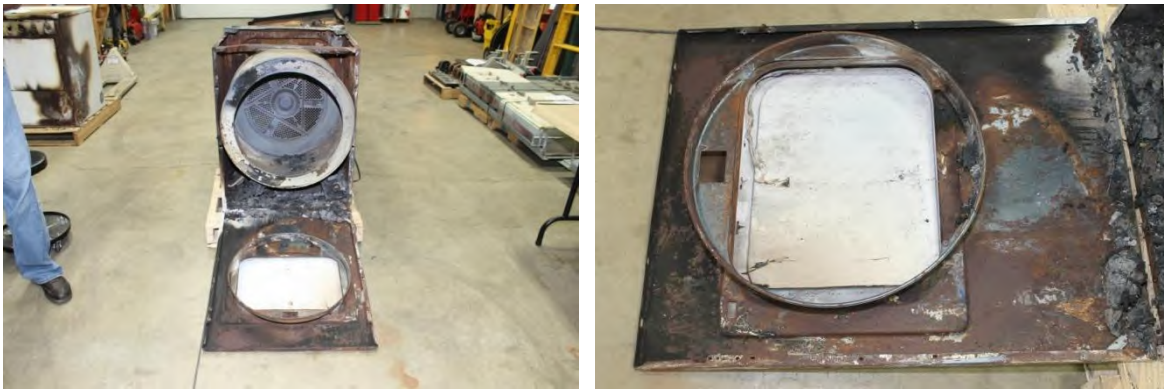
**Front Panel**

The front panel was removed from the dryer to allow further inspection of the interior of the front panel. The plastic trap duct had been consumed. Although the plastic trap ducts in the GE models were flame-retardant, the surrounding fuels in the dryer that burned allowed this plastic component to be consumed during the fire. The felt and plastic components of the front drum seal were entirely consumed. Due to the front seal components being consumed, it was impossible to determine the amount of wear to the felt material prior to the fire. Similarly, the foam that sealed the plastic trap duct to the plastic blower housing had been consumed during the fire, making it impossible to rule out a potential seal leak at this interface. It should be noted that based upon the subject dryer's date of manufacture in July of 2004, the subject dryer was the subject of a Technical Service Bulletins<sup>13</sup> issued from December 2004 through May 2005

covering dryers manufactured from 2002 to 2004 that cited a problem with the front drum seal felt being changed to a different blend, which could compress and lead to zippers, buttons and other items being lodged in the front drum seal. More importantly, later versions of these Technical Service Bulletins, for dryers manufactured from 2006-2008, discussing this felt seal variation also list “Poor Airflow” as a problem that these dryers will experience. This will be covered later in this report and all Technical Service Bulletins for these Ball-Hitch dryers are contained in Appendix II. This made it likely that internal seal leak(s) were a contributing factor of reduced airflow and subsequent lint accumulation.

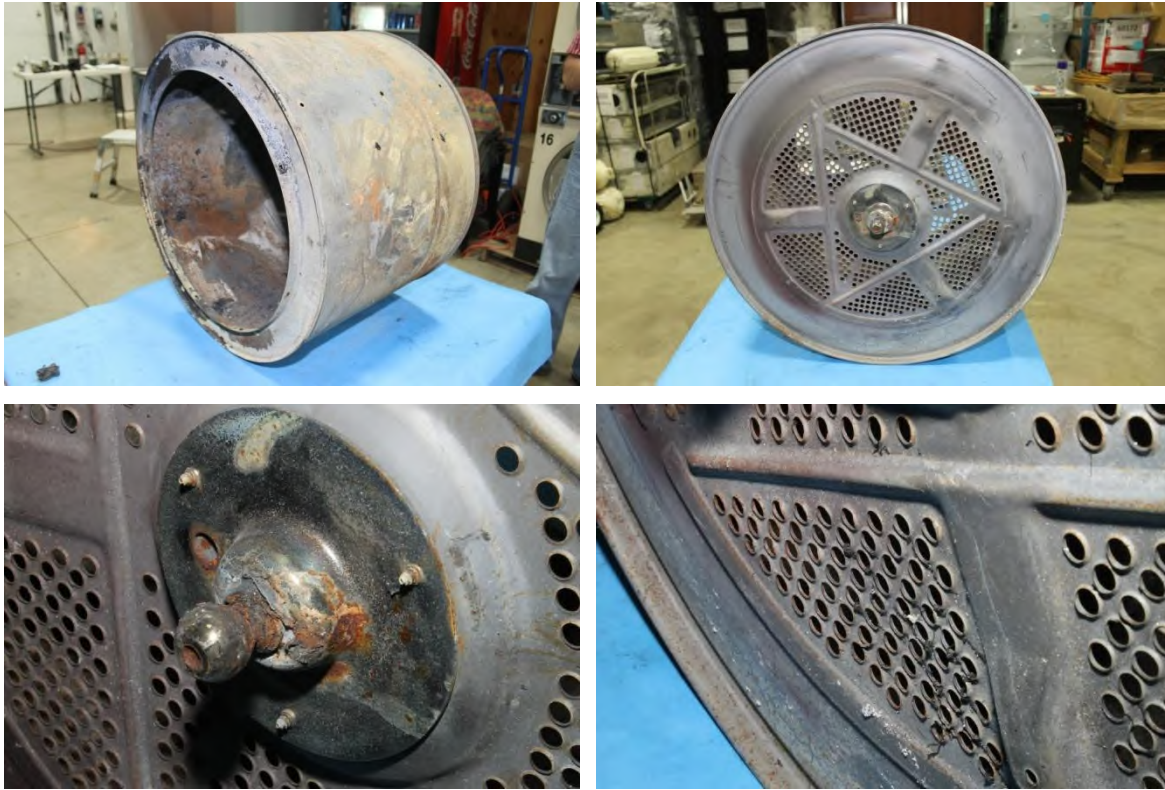
**Rear of the Drum**

The drum was removed from the cabinet. The rear of the drum was not equipped with a heat shield or “baffle”, common on newer vintages of Electrolux Ball-Hitch gas-fired dryers. There was no lint adhered to the rear wall of the drum surrounding the numerous perforations after the fire. While it is common that lint collects on the rear of the drum in the Ball-Hitch dryer design, any such lint would have been consumed during the fire. Examination of the ball pivot shaft revealed it was undamaged, with no evidence of scoring from metal on metal contact.

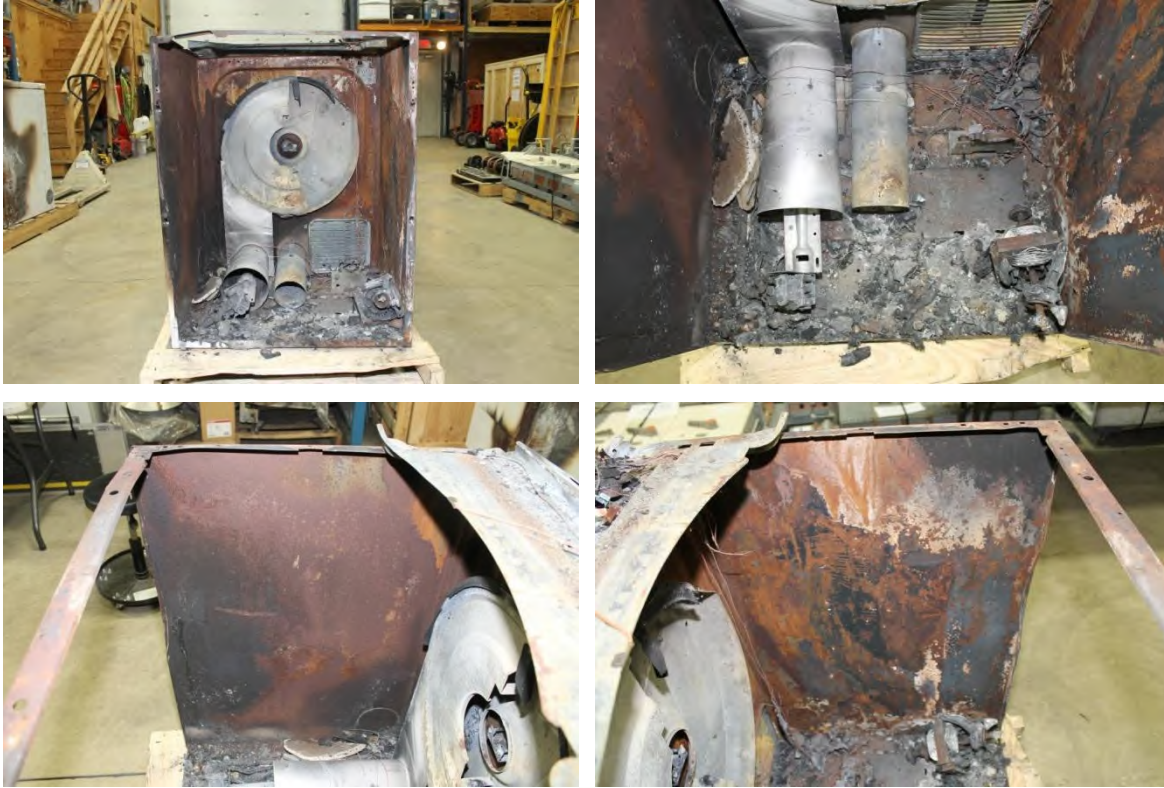
**Interior of Cabinet**

Examination of the interior of the cabinet reveals that the plastic blower housing and fan impeller were consumed. This damage was consistent with the fire patterns observed on the exterior of the dryer and was caused by the internal plastic fuel load at the lower right front corner. There was no evidence of lint within the base of the cabinet post-fire. The lack of any significant accumulation of charred lint at the front of the burner assembly provided no evidence to support the ignition of lint due to encroachment into the burner assembly or anywhere else in the base of the cabinet.

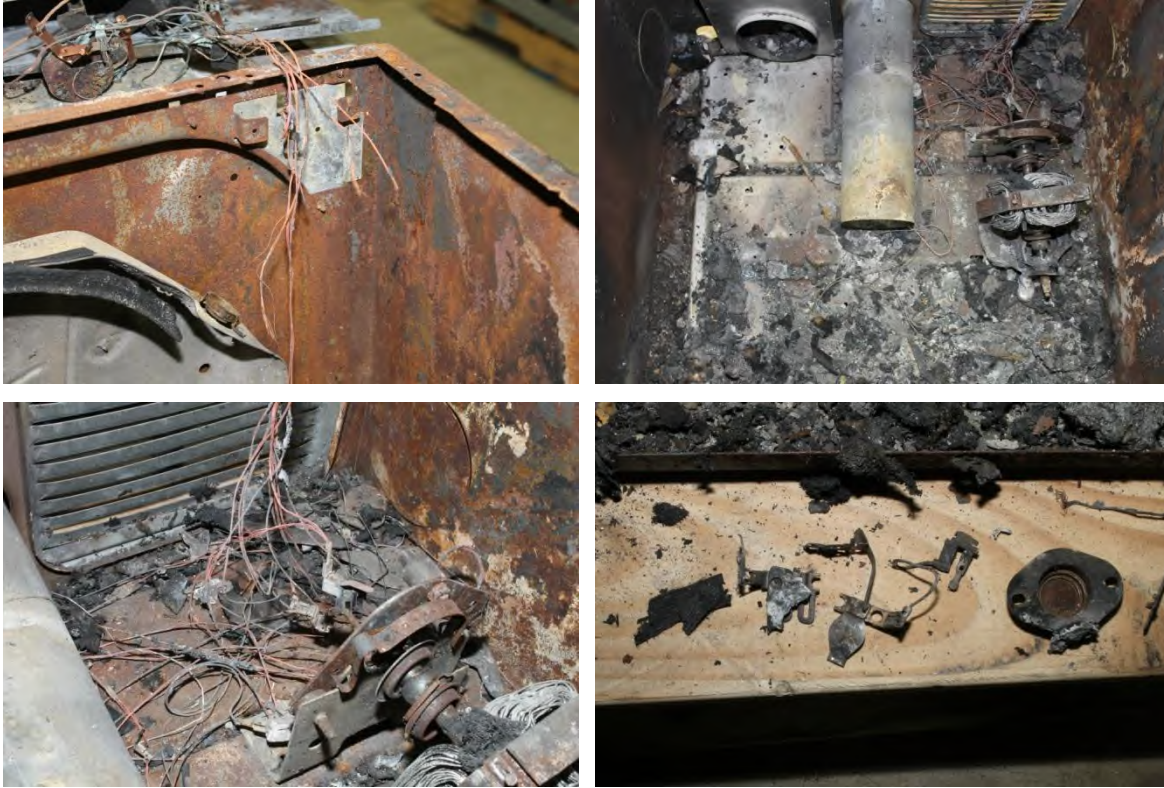
**Wiring Harness**

Examination of the remainder of the wiring harness revealed that the insulation on the lower portion of the wiring harness in the cabinet consumed and much of the harness had broken and fallen into the base of the cabinet. There was no electrical activity observed on any of the lower harness conductors or loose conductors recovered from the lower portion of the cabinet interior. None of the stranded copper conductors had any visible beading or other evidence of electrical activity. Electrolux's expert did not want to fully remove the harness to further inspect for any possible arcing or other evidence of electrical activity.

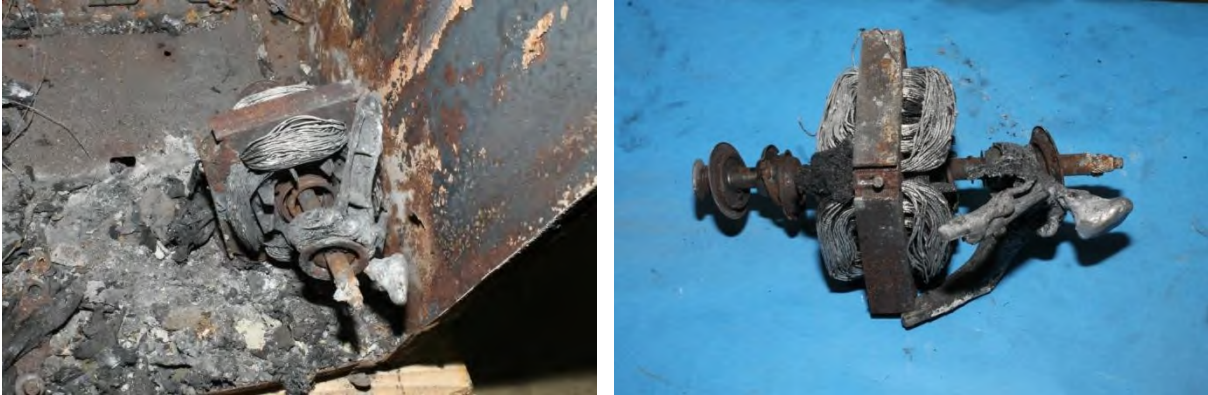
**Motor**

Examination of the motor revealed that the aluminum frame was heavily melted. There was no accumulation of lint on the motor post-fire. There was no evidence of electrical activity on the windings or the attached conductors, only melting from heat exposure. The front motor bearing had been damaged by fire and the shaft could not be rotated. The centrifugal switch was consumed during the fire and could not be manually tested for operation during the joint evidence exam.

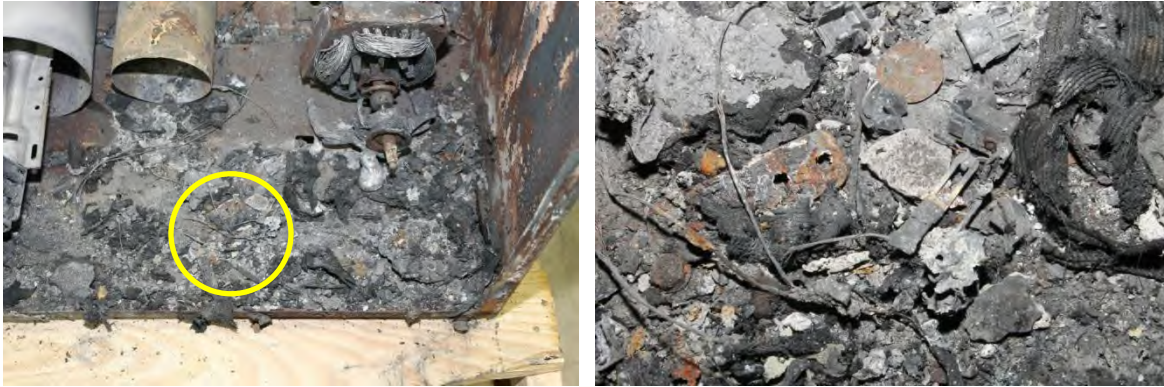
**Operational Thermostat at Blower Housing**

Examination of the operational thermostat revealed that it was destroyed when the blower housing that it was mounted to was consumed by fire. The operational thermostat was not functionally tested. Examination of the automatic resettable high limit safety switch from the one o'clock position of the heater pan revealed that it was also destroyed during the fire and the remains were found in the base of the dryer cabinet. The automatic resettable high limit safety switch could not be tested on account of the damage. A visual inspection of the contact surfaces revealed that evidence of repeated cycling was observed on the contacts. The contact surface displayed some arc marks and discoloration in a circular pattern at the center; however, there were no deformations or craters to the surface of either the fixed or moveable contacts. There was no evidence that the safety switch had welded or fused together. Based upon the physical evidence it was determined that the automatic resettable high limit safety switch had operated repeatedly over the lifetime of dryer use due to elevated temperatures behind the drum from a reduction of airflow within the dryer. Numerous factors can cause the dryer to cycle off of the high limit safety, all of which are related to reduced airflow. These could include a restricted exhaust, large loads, leaking internal seals, a blocked lint screen, etc., or any combination thereof. Numerous Electrolux service documents also list numerous causal factors that cause the high limit switch to operate, above and beyond those related to the failure to install and properly maintain dryer venting, which is almost universally one of Electrolux's experts' defenses in these

cases.<sup>14</sup> There is no way to reliably determine if any one of these factors was the sole cause. Furthermore, all of these conditions are foreseeable, hence the need for a thermal safety device(s) in all residential clothes dryer. Further discussion will follow later in this report.

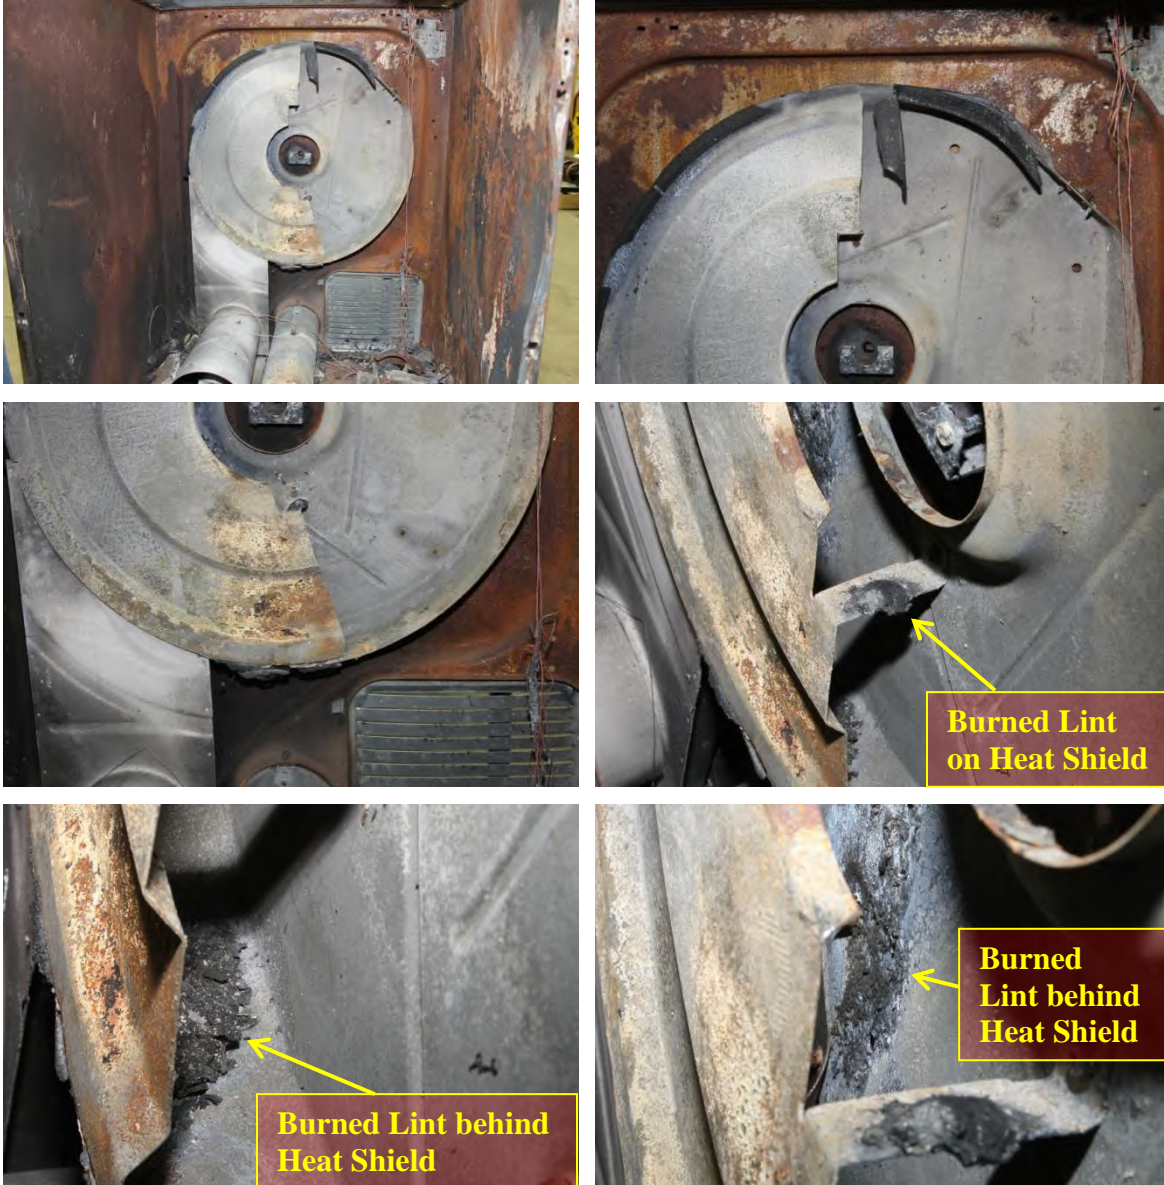
Heater Pan and Heat Shield

Examination of the heater pan mounted to the rear of the cabinet revealed it was equipped with the unique sheet metal heat shield that GE required Electrolux to install on all gas dryer manufactured for them. This is a half-moon shaped heat shield which bolts to the left side of the heater pan. The heater pan assembly, including the heat shield had sustained heavy heat and oxidation damage during the fire. The rear felt drum seal attached around the outside edge of the heater pan had been mostly consumed during the fire. A minor accumulation of burned lint was present within the heater pan and on the surfaces of the heat shield post-fire. There was burned lint on the top surface of the sheet metal offset which secured the heat shield to the vertical face of the heater pan below the Ball-Hitch opening and hitch assembly. There was also burned lint on the vertical face of the pan and on the rear of the heat shield directly above the opening where the vertical heat duct opened into the heater pan. Witness marks were observed at the lower portion of the heater pan that indicated that there had been an approximately 3-4" deep accumulation of lint at the six o'clock position of the heater pan. While the majority of this lint had been consumed during the fire, a mass of burned lint was retrieved from the cabinet below the heater pan and was reconstructed in its location at the time of the fire. After the fire, this mass of burned lint was approximately 1" deep, 5" long and fit the 2 1/4" width of the heater pan. Based upon the witness marks, this lint in the lower portion of the heater pan extended to the heat duct opening at the 7 o'clock position, where the heat from the burner enters the heater pan, to 4 o'clock position at the right edge of the heater pan. The normal operating temperature at the point where this lint was collected where the heater pan intersected with the vertical heat duct that carries the hot air from the burner assembly dryer in a dryer that is installed to manufacturer installation instructions is over 1000°F, well above the approximate 700°F ignition temperature of lint. The lint (first fuel) accumulated within the void space formed between the rear of the drum and the heater pan is in proximity to the heat source (burner flame), in a position where it is at high risk of ignition, and was determined to be the first fuel ignited.

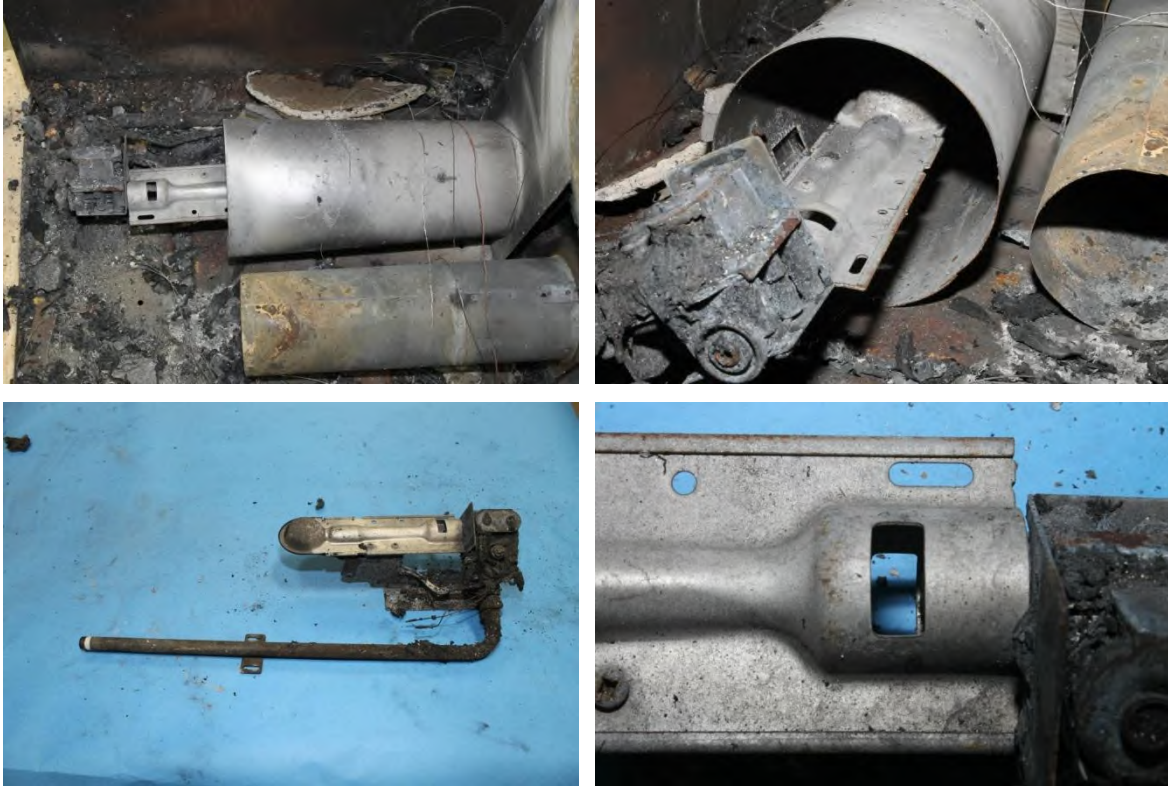
**Gas Burner Assembly**

The gas burner assembly at the lower left of the cabinet was inspected. The gas valve was visibly melted, evidence that the alloy valve body had melted during the fire and allowed natural gas to escape during the fire. This unchecked release of fuel gas caused much of the intense fire damage within the dryer. The gas valve was compromised because of the internal plastics of the dryer generating sufficient heat to melt the gas valve body during the fire, after they were ignited from burning lint that had traveled from the heater pan, through the drum and into the lint trap area. Examination of the combustion chamber and gas burner assembly also revealed that these components had no lint accumulated on them; any lint that may have been accumulated in this area prior to the fire had been consumed. The gas train was removed for further examination and the burner assembly was found to be equipped with a size 44 orifice, which is appropriate for natural gas. With the burner assembly removed, some fire debris, burned cloth, melted aluminum from the motor frame and a drum paddle screw were found to the rear of the combustion chamber at the base of the vertical heat duct where it had intersected with the tube of the combustion chamber where the flame was located. These items had all migrated into the vertical heat duct post-fire. While it is possible that a piece of lint had fallen down in this area during operation and was the first fuel ignited in the combustion chamber, any available post-fire patterns would have been destroyed or obscured due to the heavy fire damage within the dryer cabinet. Therefore, it is just as probable that the first lint ignited could have been within the heater pan at the top of this vertical heat duct. Regardless of the exact point of first ignition, the lint that collected in the path of airflow between the gas burner and the rear of the drum was the first material ignited in this fire.

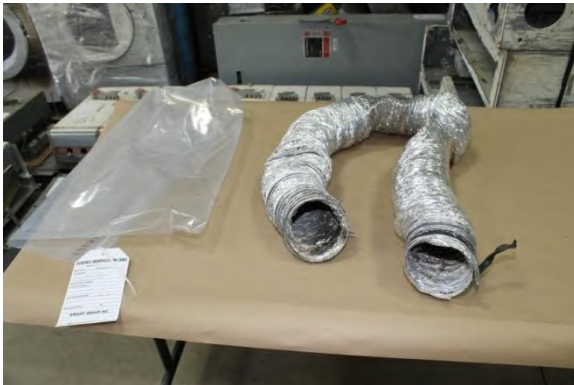
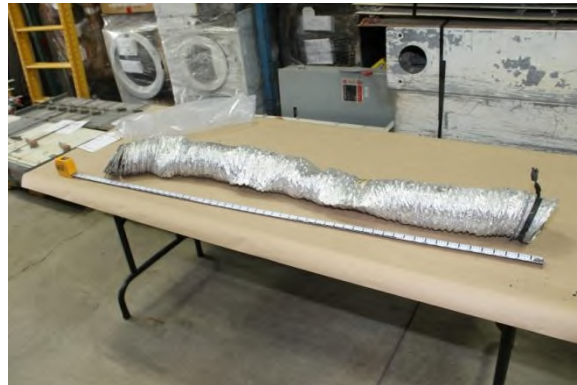
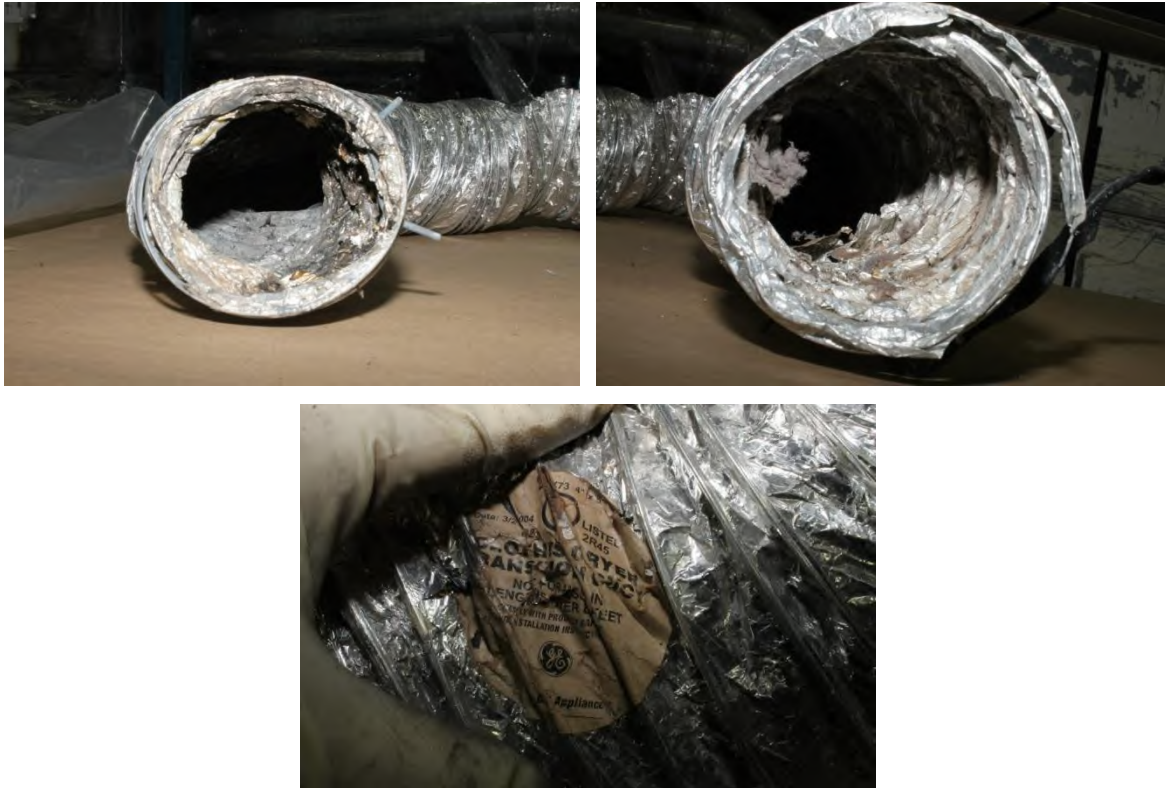
**Clothes Dryer Transition Duct**

The majority of the venting for the dryer was included as evidence. As discussed in review of the Origin & Cause Investigator's scene photographs, the clothes dryer transition duct was and the exterior vent hood were recovered, but the short rigid metal duct pipe that was part of the hood assembly had been removed by firefighters and was not collected during the joint scene examination. The transition duct that connected the dryer to the permanently installed duct was a UL Listed Clothes Dryer Transition Duct constructed of flexible foil, comprised of 101 wire coils and measuring approximately 4'6" in length at rest. The interior of the flexible foil transition duct contained a light layer of lint and was not blocked or obstructed. The coils of the duct were distorted in three distinct areas consistent with post-fire damage but there was nothing to indicate that the transition duct had been kinked, crushed or otherwise damaged prior to the fire. The label indicated the transition duct was manufactured in March of 2004, indicating it was originally installed with the subject dryer. This was consistent with the Mr. Vitale's testimony. While the Installation Instructions for this dryer did not recommend the use of flexible foil ducting anywhere in the vent system, there was no physical evidence that the simple use of this short section of foil transition duct was a substantial contributing factor in the accumulation of lint within the dryer. Further information on the expected and foreseeable use of flexible foil transition ducts will be included later in this report.

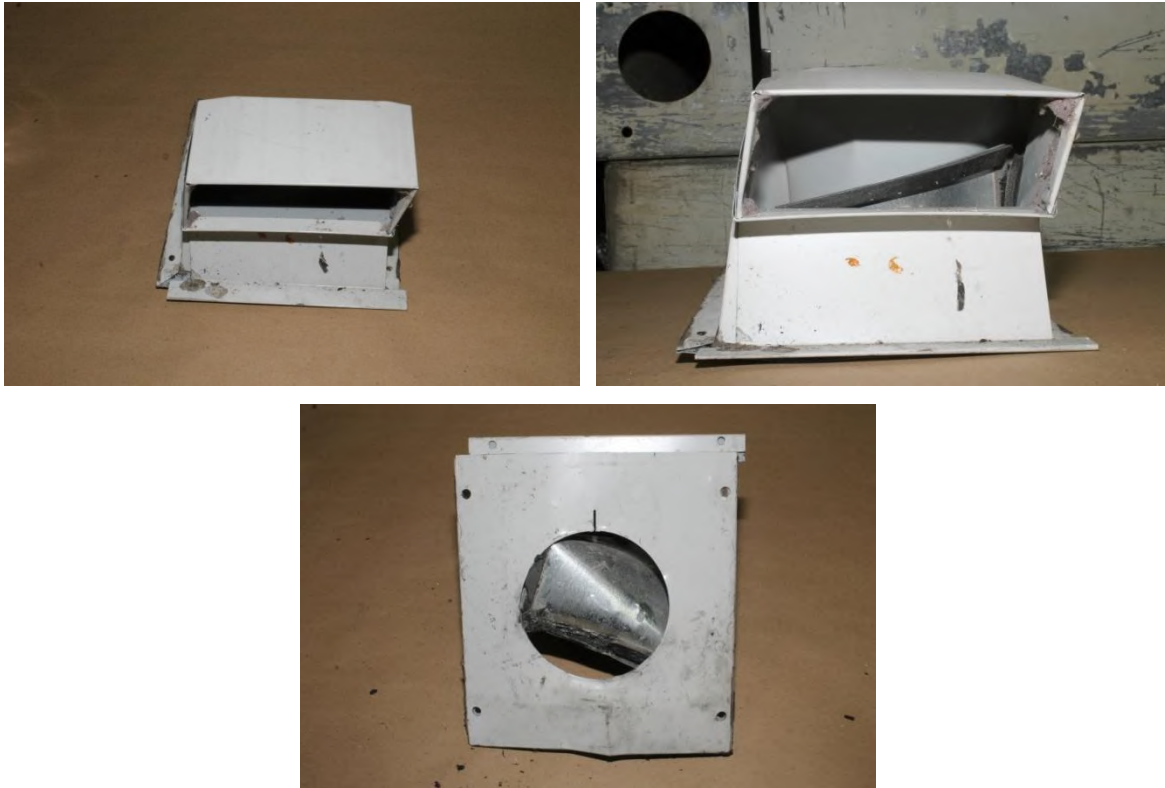
**Exterior Vent Hood**

The 2 ½” metal vent hood was a roof style hood, although it had been installed on the exterior wall. The hood was constructed of heavy sheet metal and was equipped with a backdraft damper that was in proper working order. The hood was not equipped with any screen or guard. The hood had only trace amounts of lint inside. Since the section of pipe that had been attached to the hood that passed through the wall was not collected it could not be examined. However, based upon the type of vent hood this would have been a rigid metal round duct pipe approximately 6”-12” long and, given the minimal lint accumulation in the available venting, likely would have had trace to minor quantities of lint inside of it. Based upon the venting, the dryer was installed in a reasonable and foreseeable manner, using common and appropriate vent materials. Also, the total interior condition of the venting revealed that the dryer’s vent system was not obstructed or otherwise configured in a manner that would reduce airflow and that it was cleaned on a period basis. This was also consistent with Mr. Vitale’s testimony that he cleaned the dryer venting yearly.

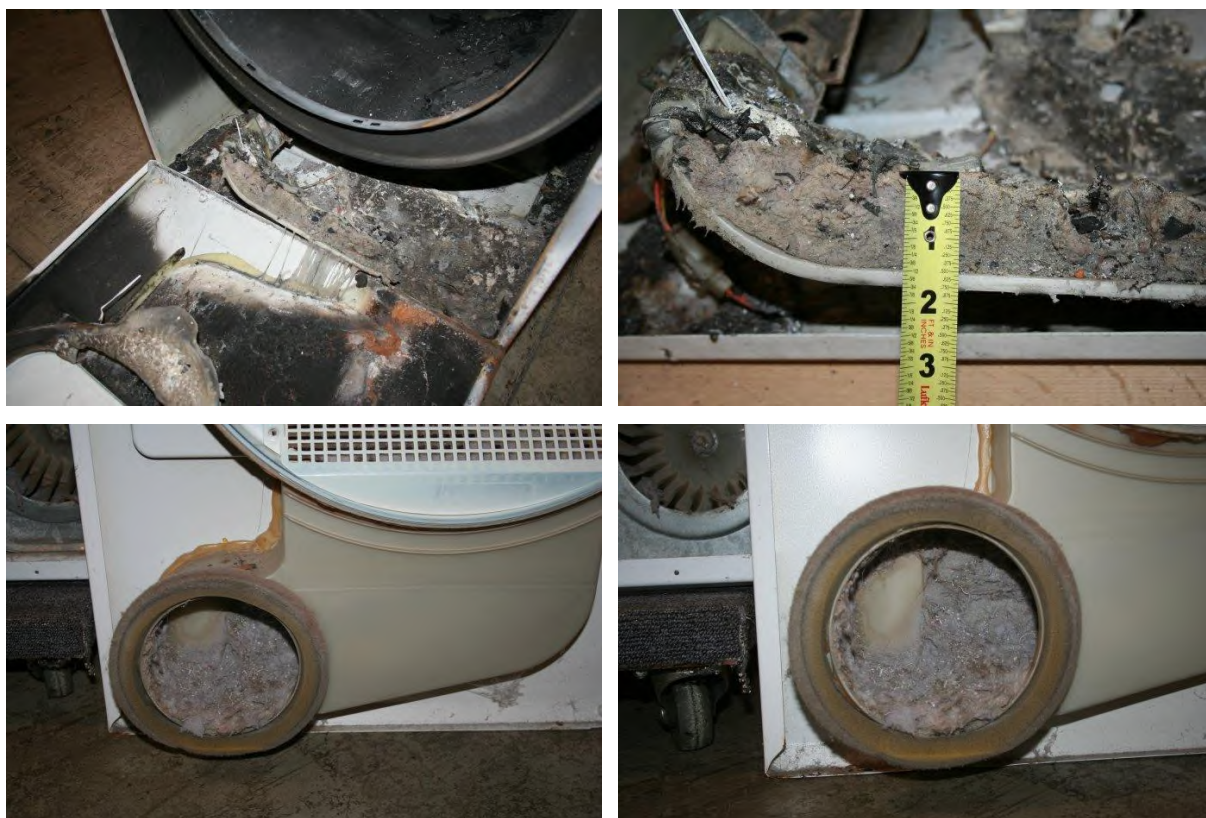
**Photos of Lint Accumulations in Exemplar Burned and Unburned Dryers  
(At the Remains of the Trap Duct)**

Lint particulate also travels through the front of the drum into the components downstream, as outlined in the diagram above. The first and most obvious lint collection area is the lint filter screen at the lower front side of the drum opening in the front panel. This component is constructed of a plastic frame with a plastic, nylon or similar screen material. Downstream of the lint screen is the trap duct/blower housing assembly. All airflow within the dryer during operation is funneled through this choke point. The restriction, elbows and component materials cause a heavy accumulation of lint in this area. The trap duct is made of plastic and tapers to a restrictive elbow at the lower corner of the front panel. The adhesive used at the factory to glue the trap duct to the front panel remains tacky during its lifetime and any lint introduced will bond to the adhesive in the trap duct area. It is connected via a foam gasket to the blower assembly, which is also made from plastic and houses the fan impeller. If improperly installed, the foam gasket that forms the seal between the trap duct and blower housing can result in reduced airflow.

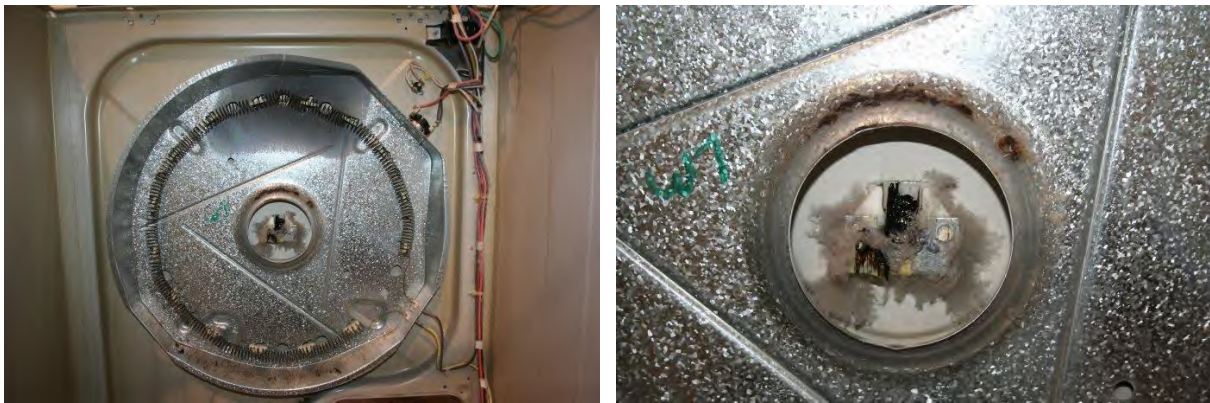
**Photos of Lint Accumulations in an Exemplar Unburned Electric Dryer**

A significant quantity of lint collects within the heat diffuser (in gas dryers) or in the heater housing assembly (in electric dryers), which are located directly behind the drum. The gas dryer diffusers collect significantly more lint in this location than the electric, though both allow for lint to accumulate dangerously close to the heat source in either variation. Electric dryers have a deflector ring attached to the rear of the drum that collects lint and stores it against the rear of the drum, which is another significant lint collection location as it provides an opportunity for lint to detach from the rear of the drum and fall onto the heating element. In addition, this quantity of lint is an excellent source of secondary spread fuels that is in very close proximity to the heating element located directly behind the drum. The gas-fired dryers are equipped with a felt seal that surrounds the diffuser and forms a seal between the diffuser and the rear of the drum. The purpose of the seal in the gas dryer is to force the air to be drawn through the burner tube so the gas flame can heat the air as it is drawn into the diffuser and then is directed into the drum. Due

to this seal forming an enclosure between the diffuser and rear of the drum, there are no openings through which any lint can escape. For this reason it is common to see large quantities of lint accumulated in the lower portion of the heat diffuser, immediately adjacent to the vertical heat duct that carries the heated air from the gas burner in the base of the cabinet. Though there are differences in the mechanisms by which the lint collects in the area behind the drum between the gas and electric designs, both allow for collection of lint in close proximity to the heat source which provides a higher probability of a lint fire occurring than alternative designs used in the industry.
